Rimkus Consulting Group, Inc.
Eight Greenway Plaza, Suite 500
Houston, TX 77046
(800) 580-3228 Telephone
(713) 623-4357 Facsimile

Re: RCG File No: 11009971
LLV Number: 0209452
VMF Location: 1530 Greensmark Drive in Houston, Texas
Subject: Final Report

Rimkus Consulting Group, Inc. was retained to examine LLV 0209452, VIN 1GBCS10E4M2908832. The fire occurred on June 13, 2016 at around 12:30 P.M. the operator of the vehicle at the time of the fire, was unavailable for interview but reportedly stated the vehicle's engine died while delivering mail on his route and backfired during subsequent attempts to restart it. Soon thereafter, smoke was observed from beneath the hood as well as flames.

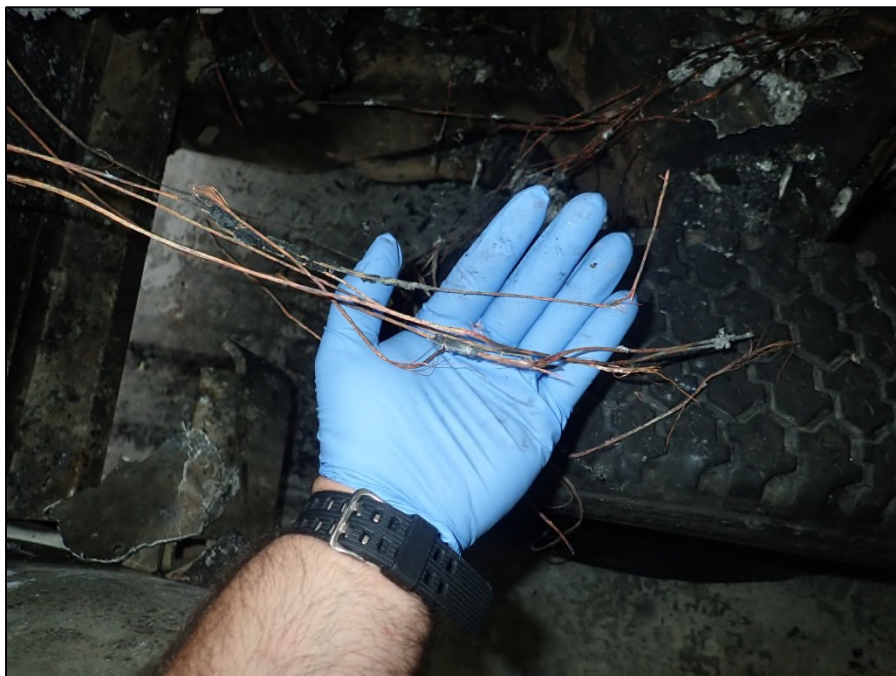
Photograph 4

3. The specific ignition sequence and cause of the fire was determined to be due to an adverse electrical event in the wiring for the daytime running lights. Based on the location of the electrical activity we determined the wiring for the light was routed along the quarter panel where the bracket for the windshield washer was located. It was determined that the severe loss of mass in this area was the result of the wiring chaffing on the metal vehicle parts degrading the protective insulation causing the wiring to fault and ignite the insulation of the wiring and nearby combustibles.

Adverse electrical activity.

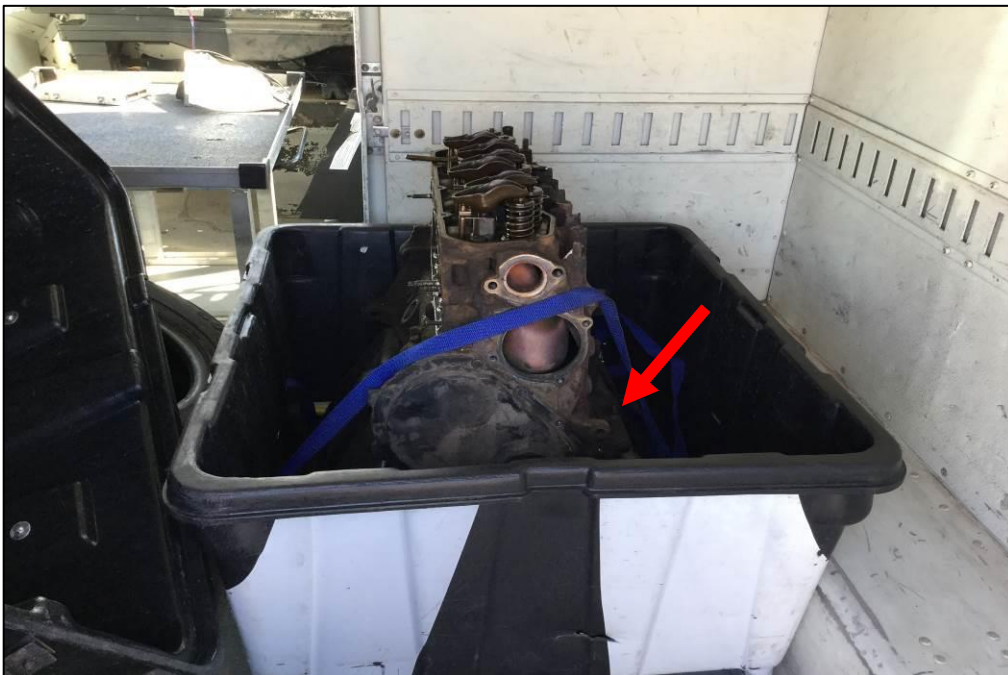
Photograph 4
Engine assembly, removed prior to inspection. Red arrow denotes block damage.

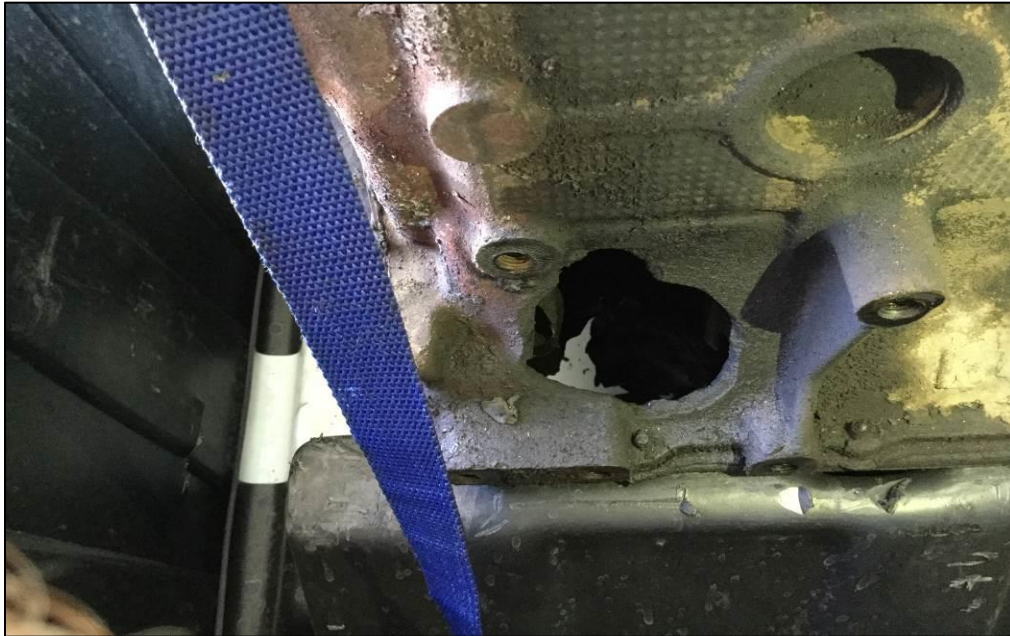
Photograph 5
Damage to engine block.

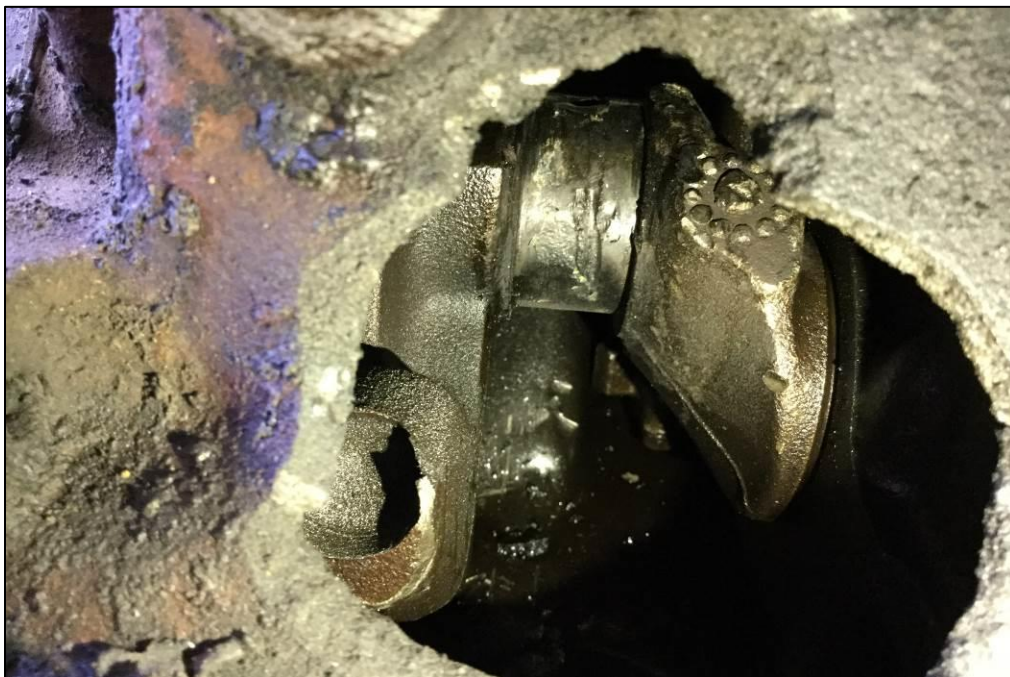
Photograph 6
Internal engine damage.

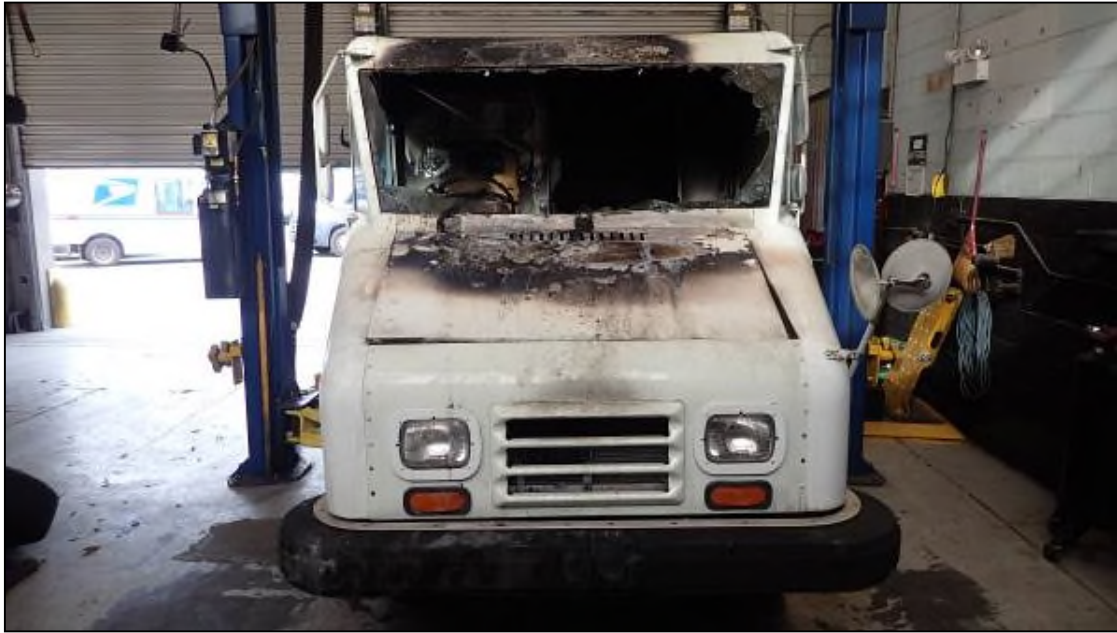
Photograph 1

View of the fire movement patterns along the front exterior.

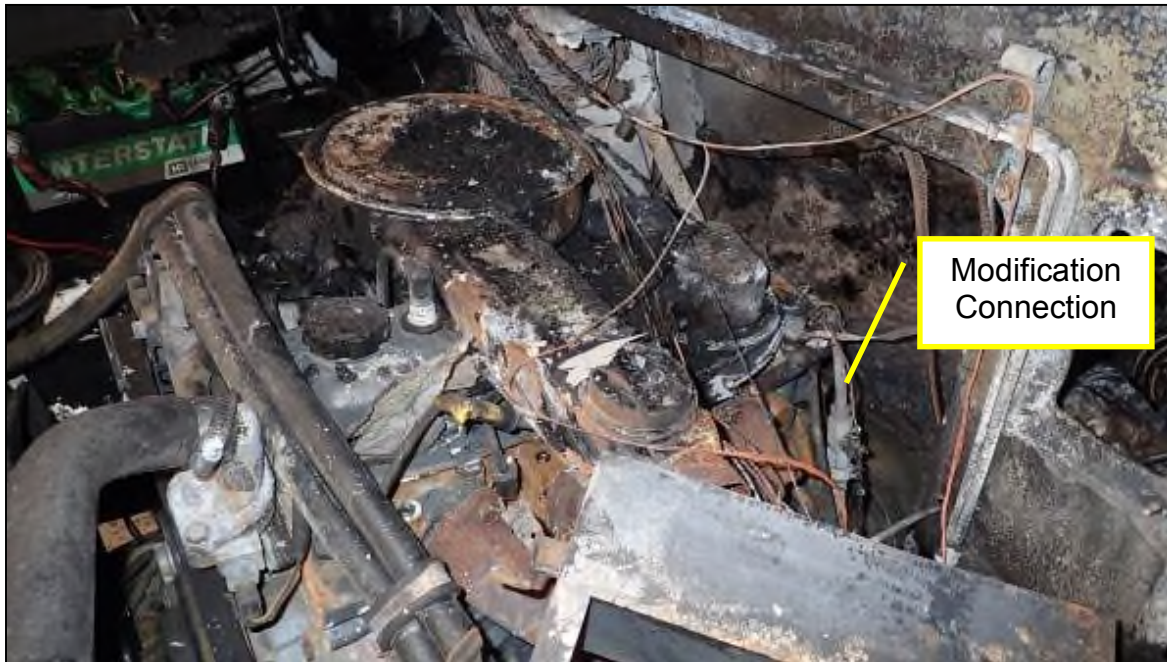
Photograph 3

View of the fire origin along the rear passenger side of the engine.

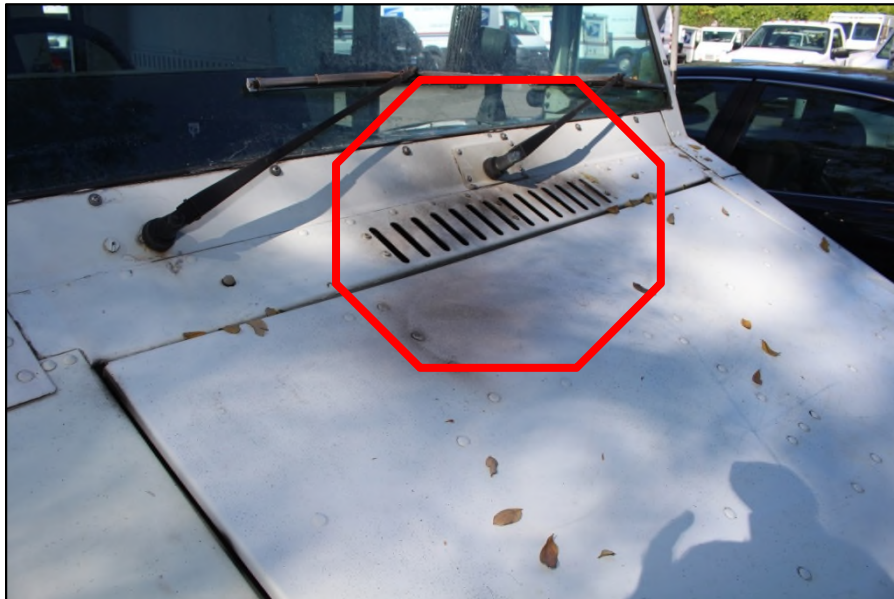
Photograph 2

Discoloration caused by heat damage was observed on the front hood of the LLV.

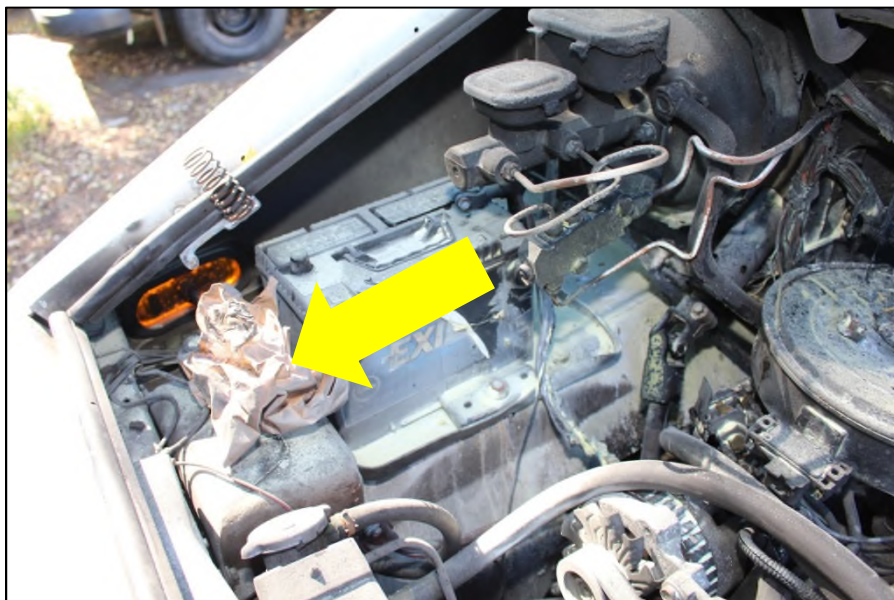
Photograph 4

Remnants of a crumpled paper bag and cellophane tape were found in the engine compartment.

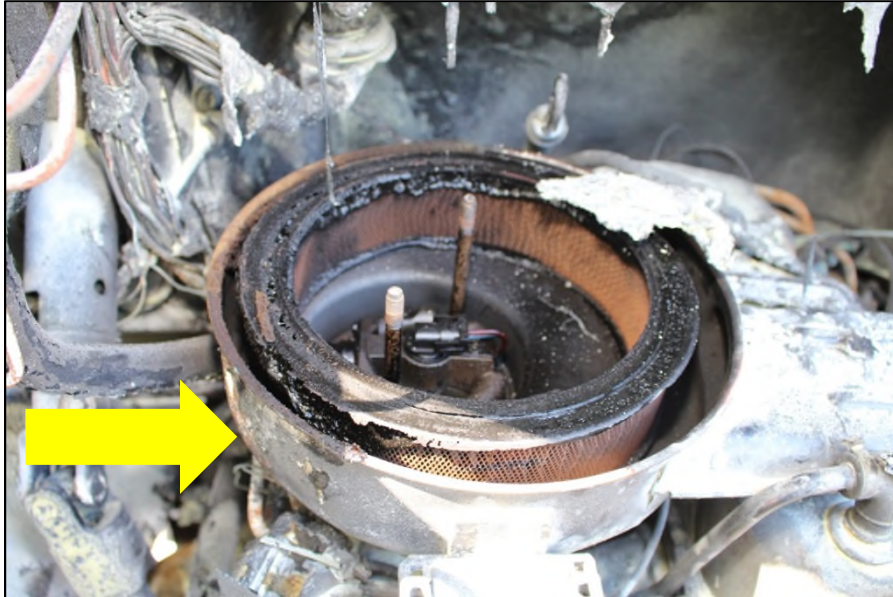
Photograph 7

The air cleaner sustained greater damage on the driver's side as compared to the left side.

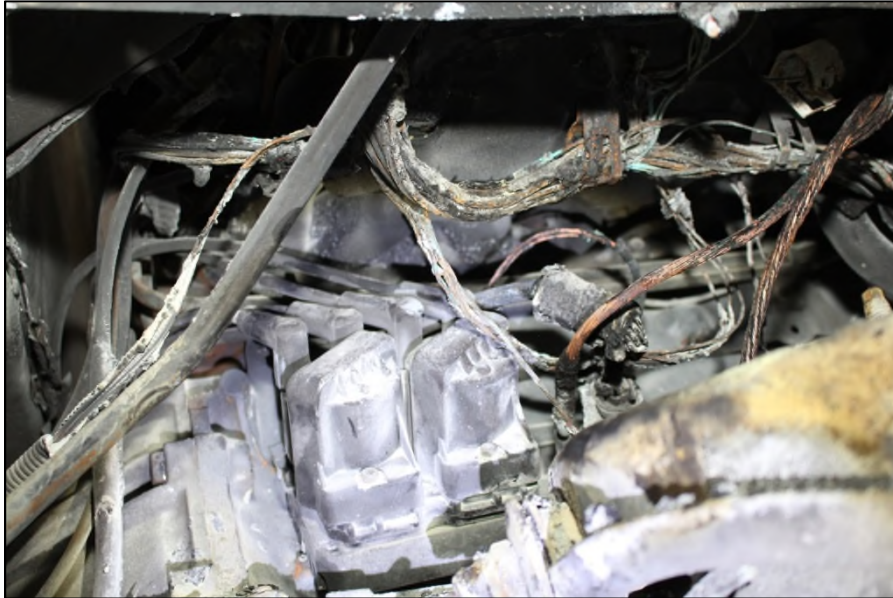
Photograph 9

A close-up view of the damaged main wiring harness.

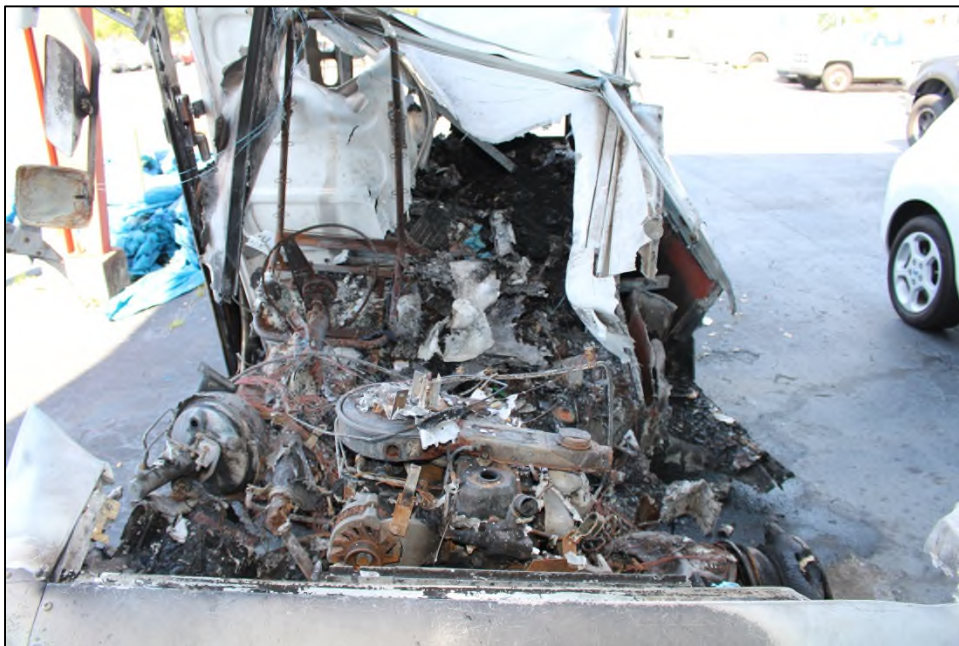
Photograph 2

View of the engine compartment and extent of the fire damage.

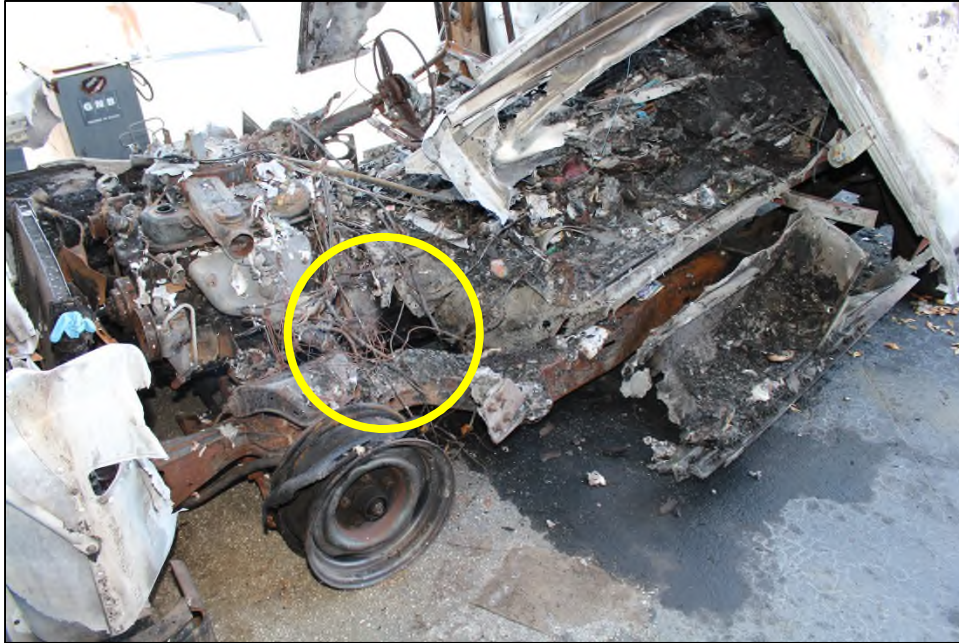
Photograph 3

The greatest fire damage in the engine compartment was observed on the left side of the engine block.

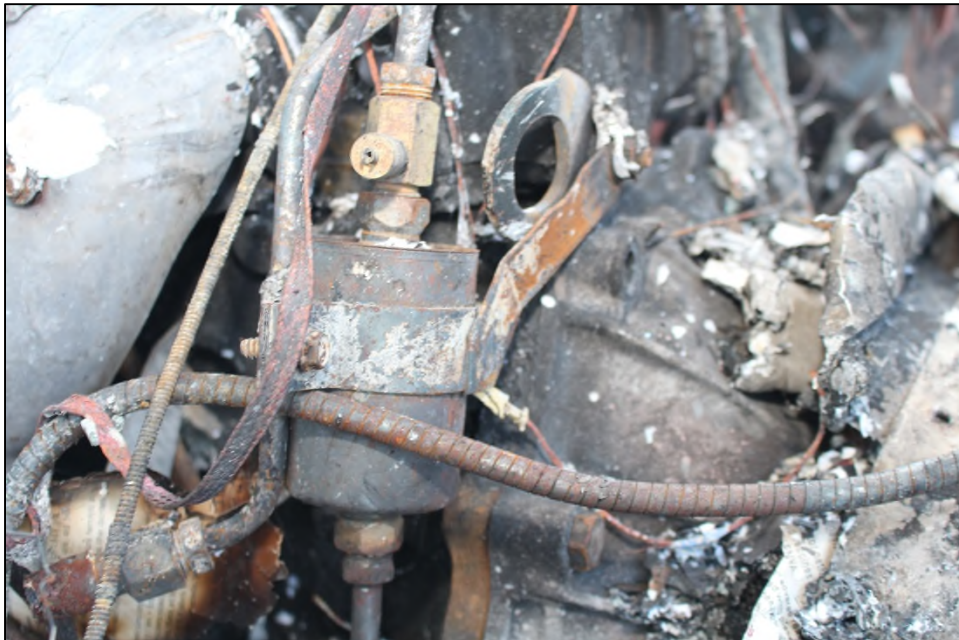
Photograph 4

The fuel filter was positioned on the left side of the engine compartment and in the area of origin.

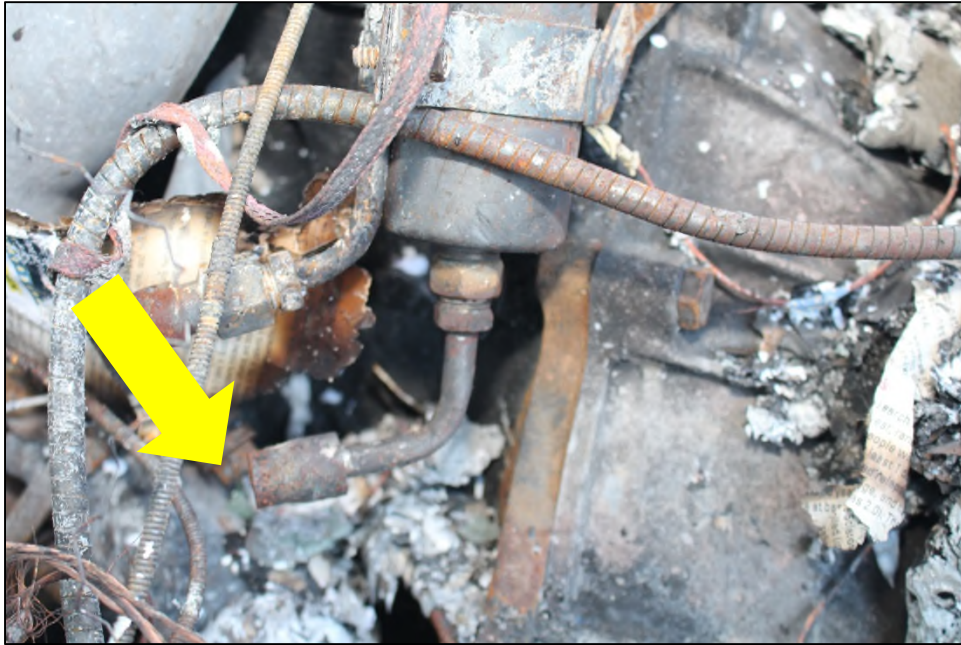
Photograph 5

A section of the fuel line was found to be missing.

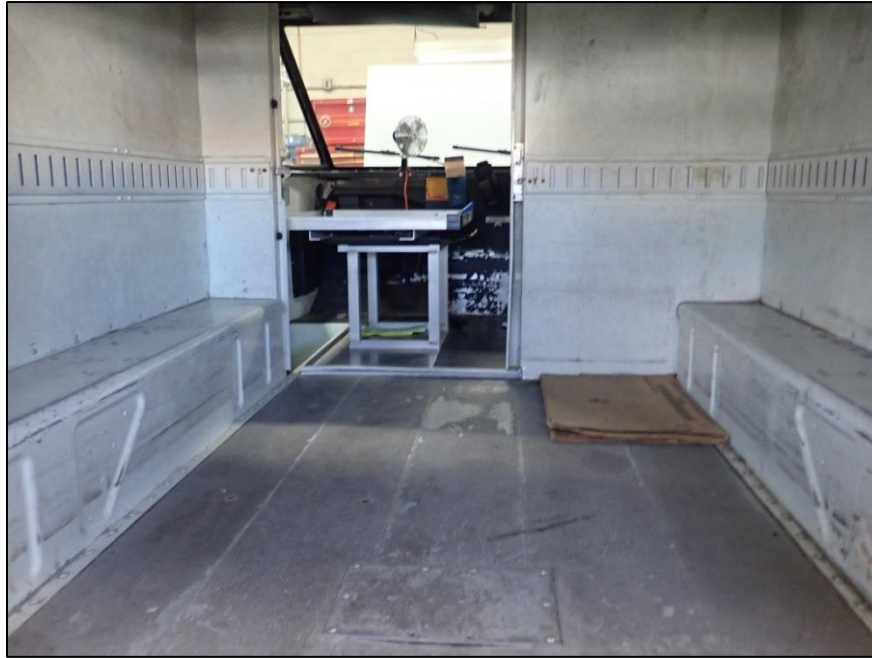
Photograph 5

Minor smoke staining was observed in the cargo compartment.

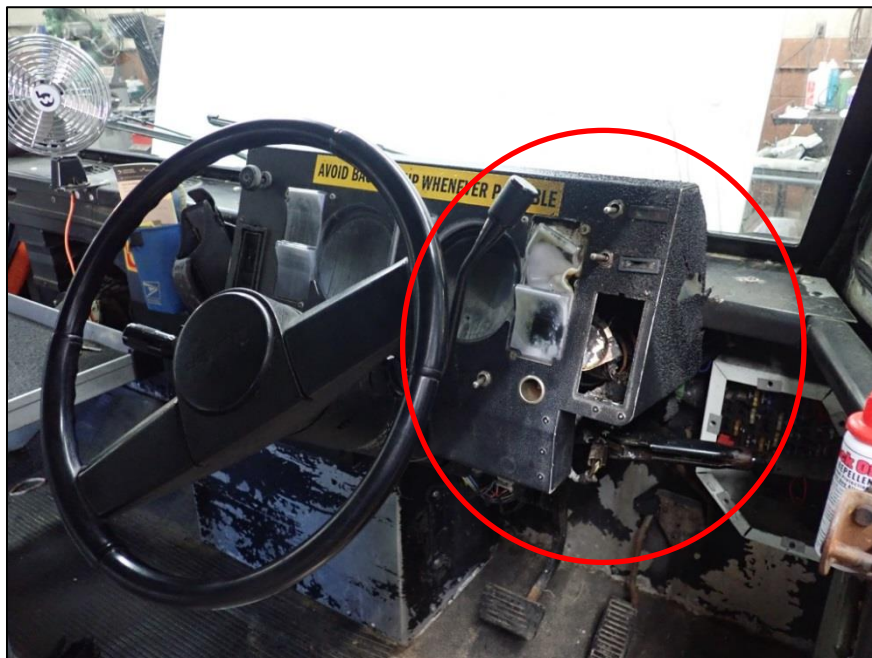
Photograph 6

Fire damaged was observed to the right side dashboard in the driver compartment.

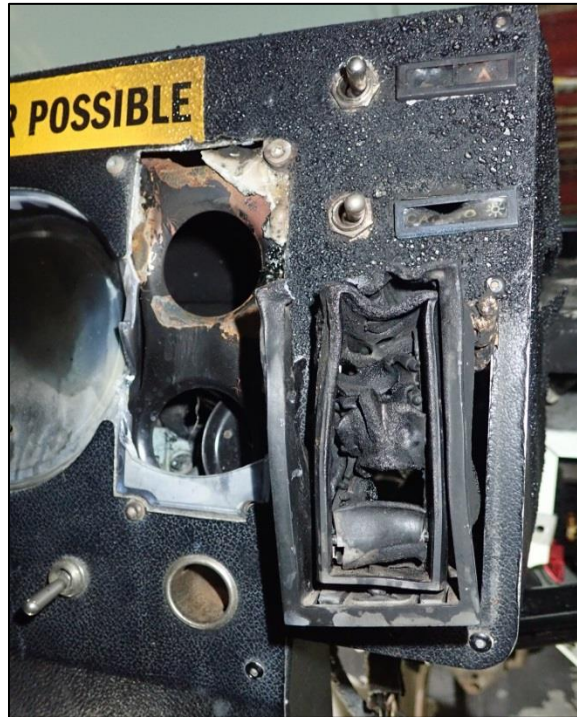
Photograph 9

Fire damage observed on metal and plastic dash components outside area of fire origin.

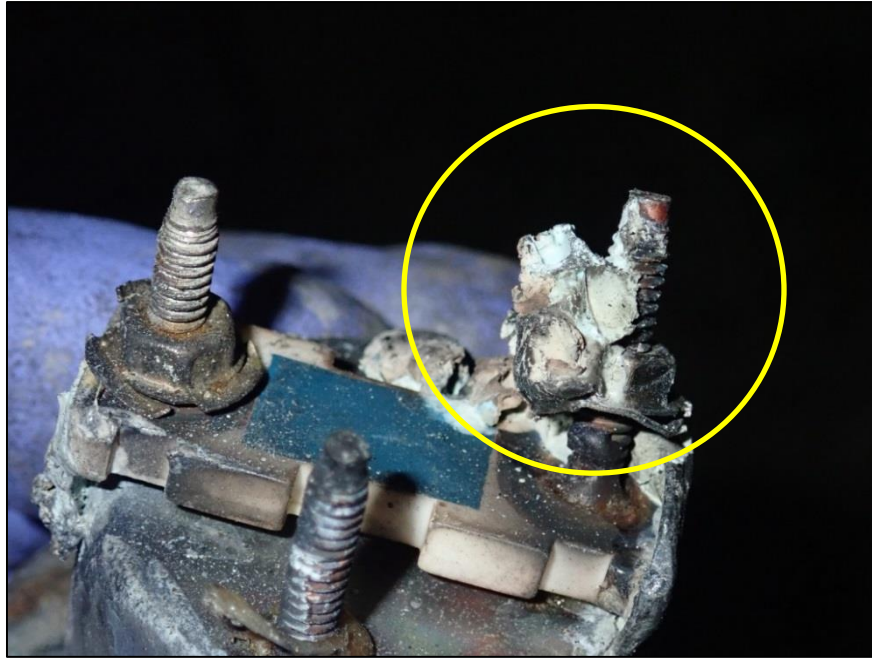
Photograph 10

Fire damage and electrical activity indicators were observed on amp gauge terminals.

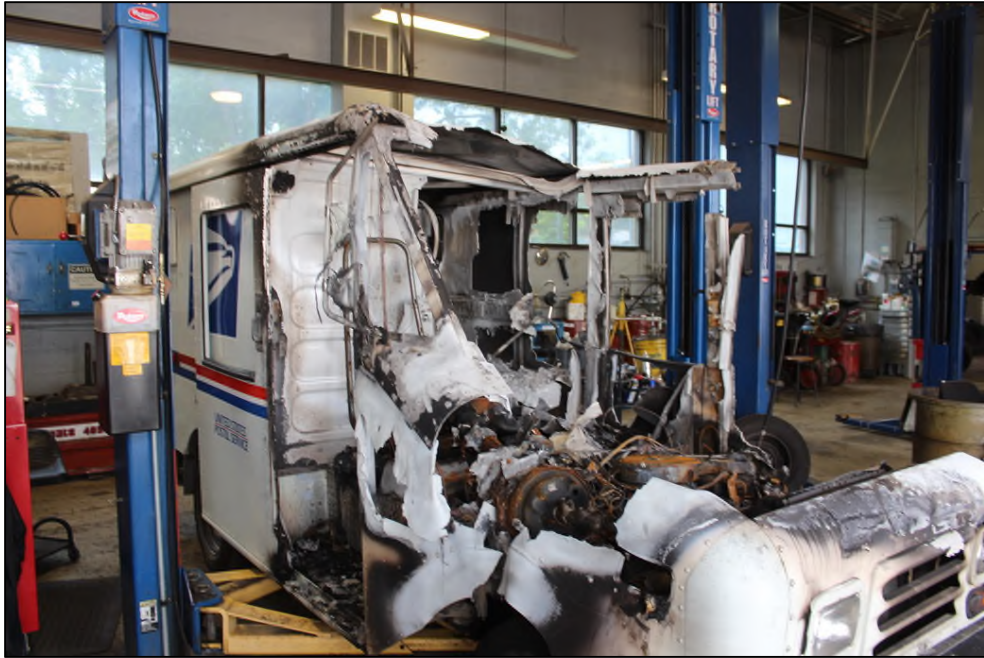
Photograph 1

Right front fire damage to driver compartment and engine compartment.

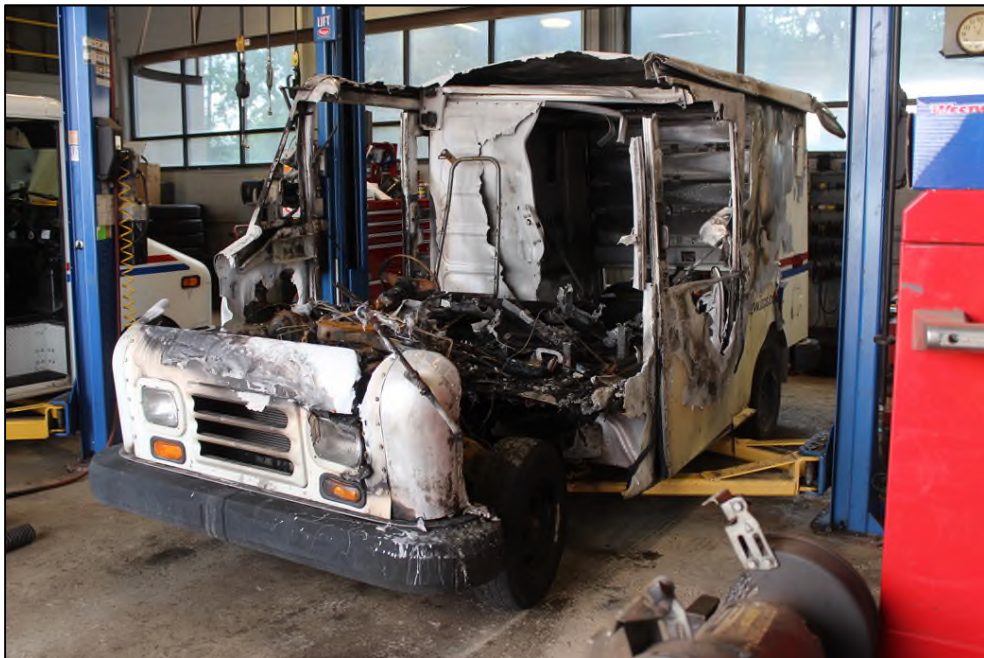
Photograph 2

Left front fire damage to driver compartment and engine compartment.

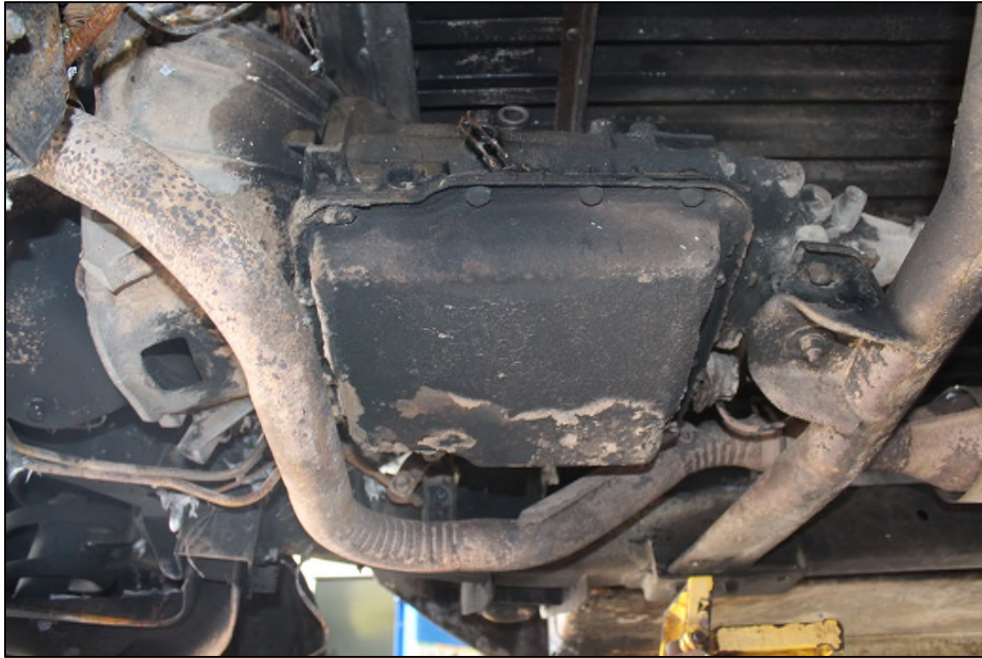
Photograph 3

1. The fire was determined to have originated at the transmission and crossover exhaust pipe under the engine compartment of the involved LLV.
2. The specific point of origin could not be conclusively identified due to the severe fire damage to the area of origin and the lack of remaining physical evidence for examination.
3. The specific ignition sequence and cause of the fire was inconclusive, however, a direct result of ignition of either leaking or atomized engine or transmission fluid coming in direct contact with a hot surface of the components in the area of the transmission and crossover exhaust pipe could not be eliminated.
4. Based on our observations, it is probable that a mechanical failure occurred allowing the loss of transmission fluid. The fluid being ignited by the hot surface of the exhaust pipe could not be eliminated.

Fire patterns in area of fire origin undercarriage at transmission pan and exhaust pipes.

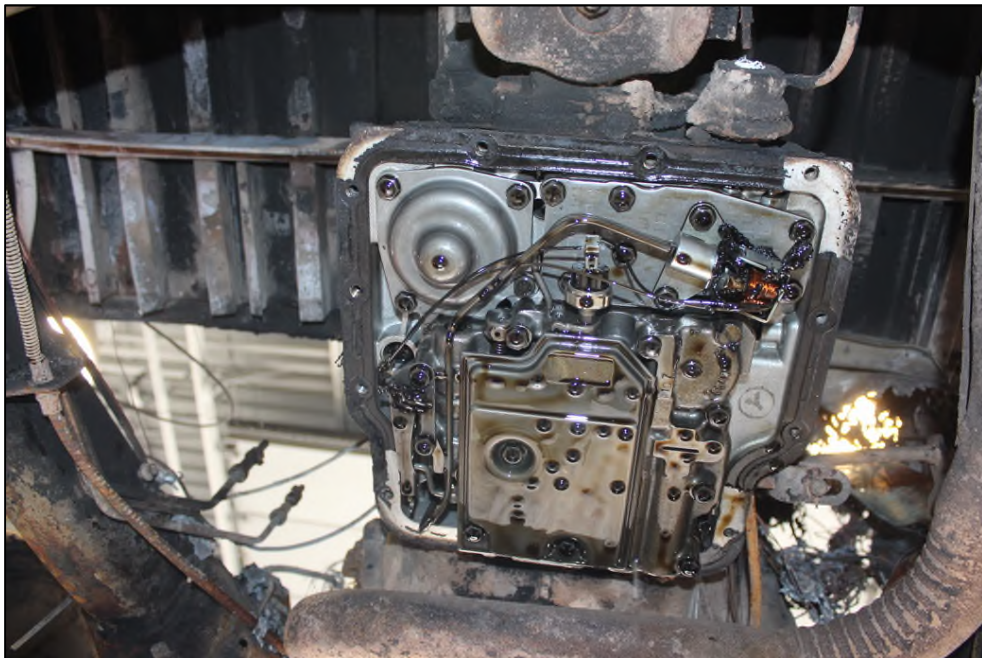
Photograph 4

Interior of transmission with pan removed, heat damaged components inside.

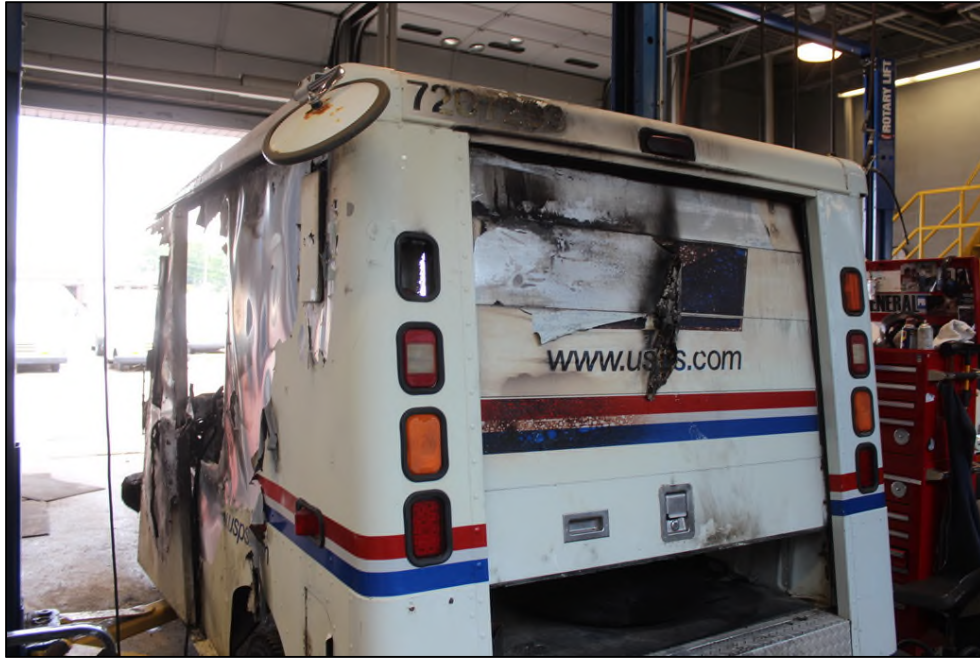
Photograph 5

Rear of vehicle with heat damage roller door jammed in position found, would not open.

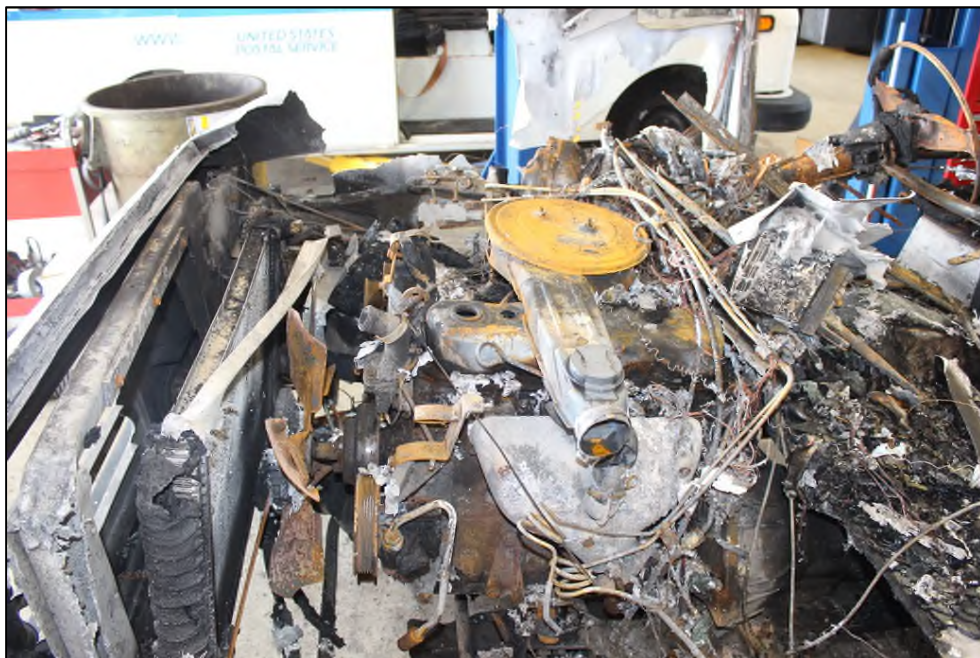
Photograph 6

Engine compartment fire damage with dashboard mass loss.

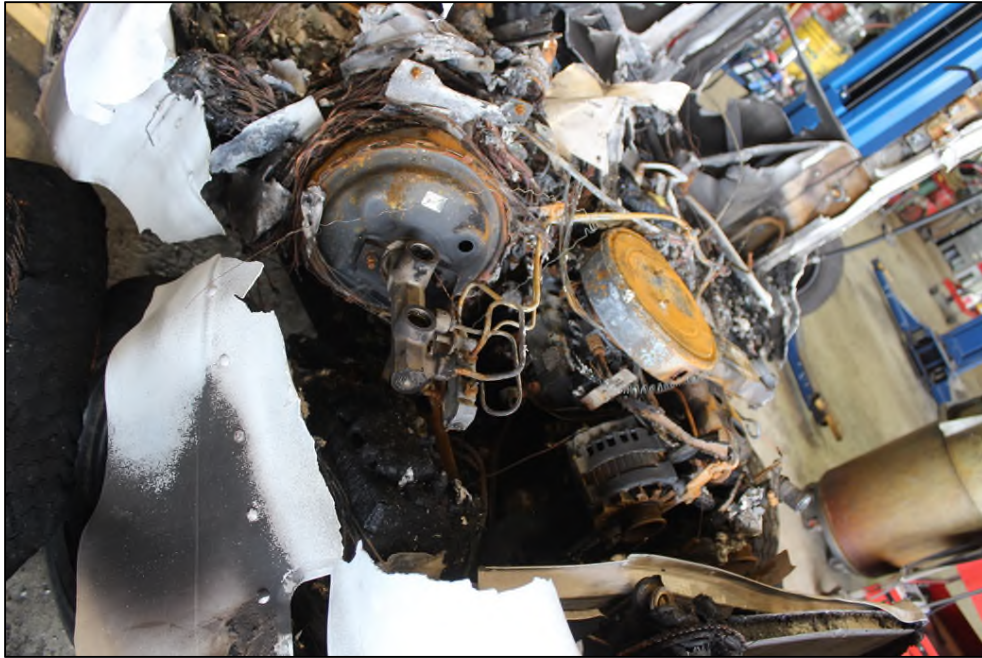
Photograph 7

Driver's side of engine compartment.

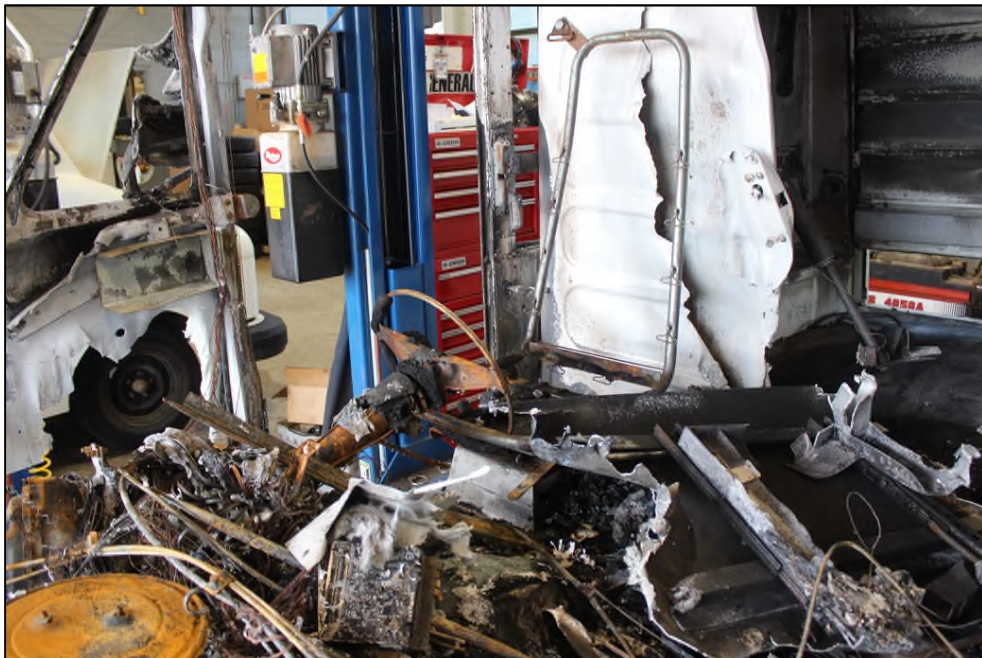
Photograph 8

Driver compartment damage, all combustible components consumed by fire.

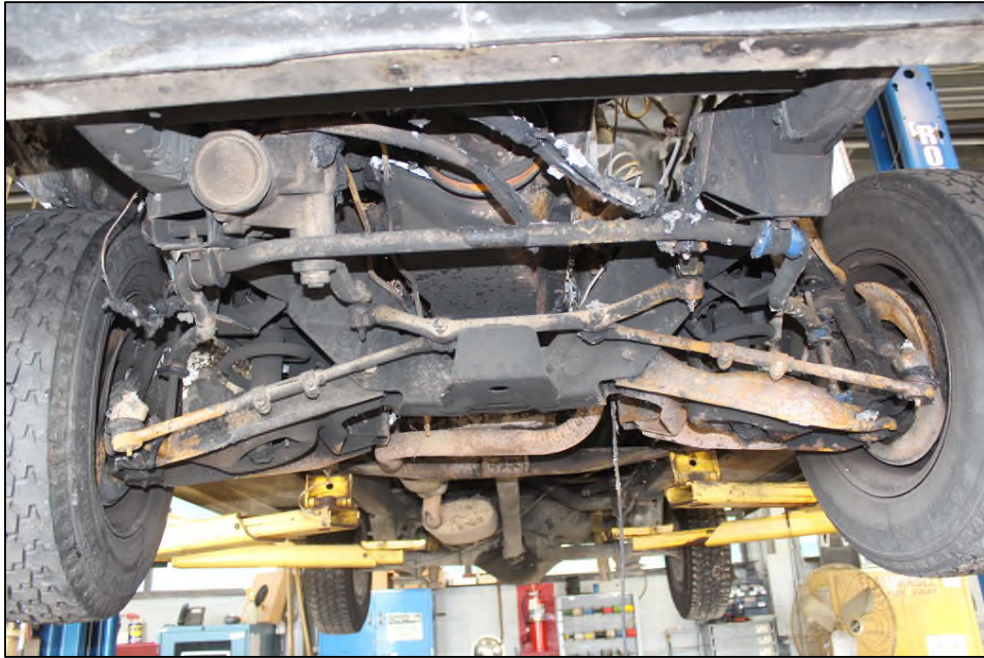
Photograph 9
Front undercarriage damage.

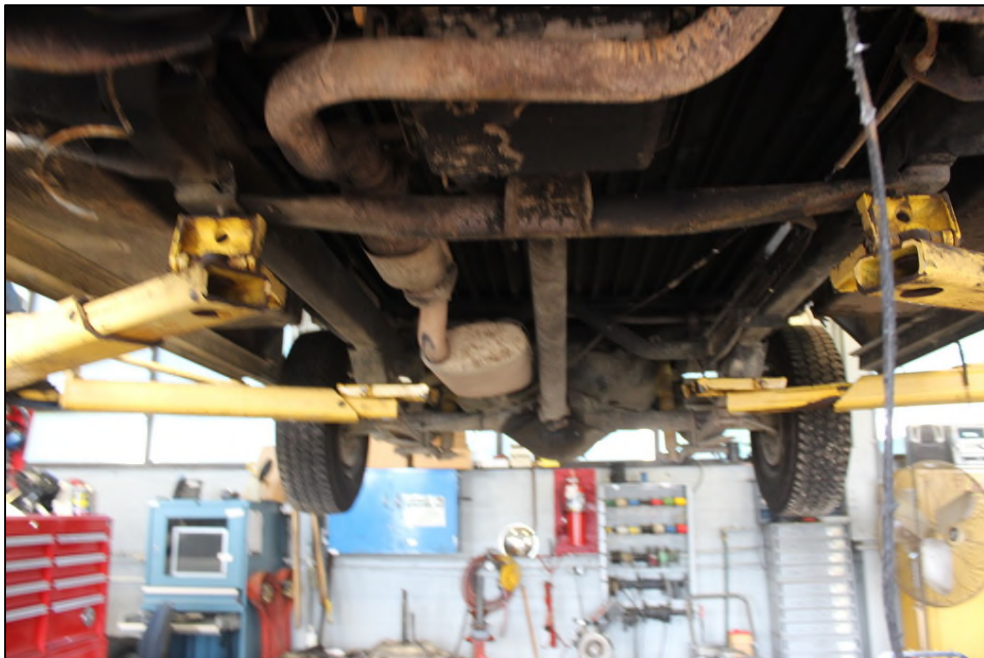
Photograph 10
Rear undercarriage and exhaust system intact with fire damage from transmission area.

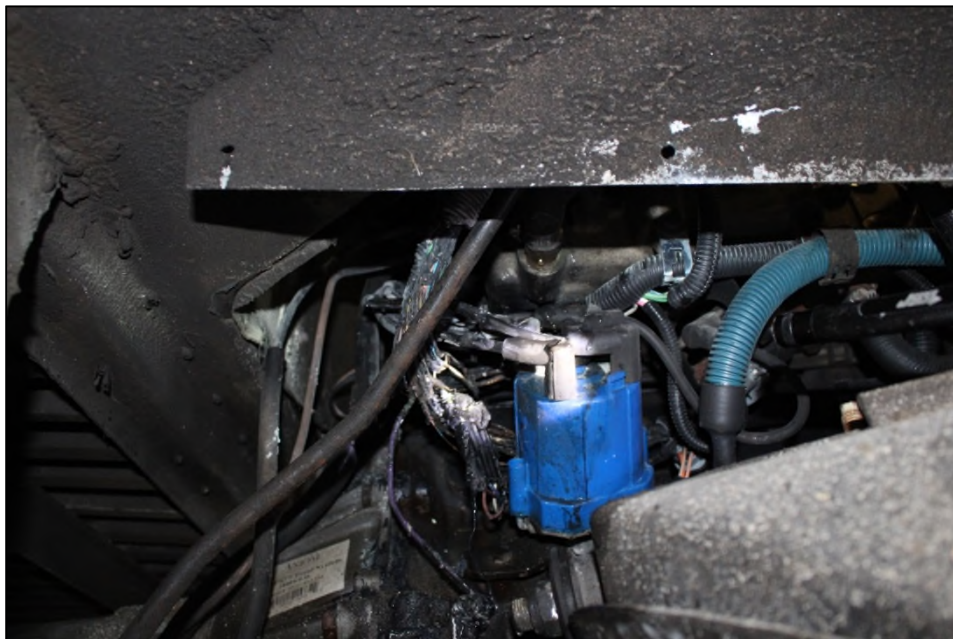
Photograph 10

Over view of the area of origin located on the lower left area of the engine.

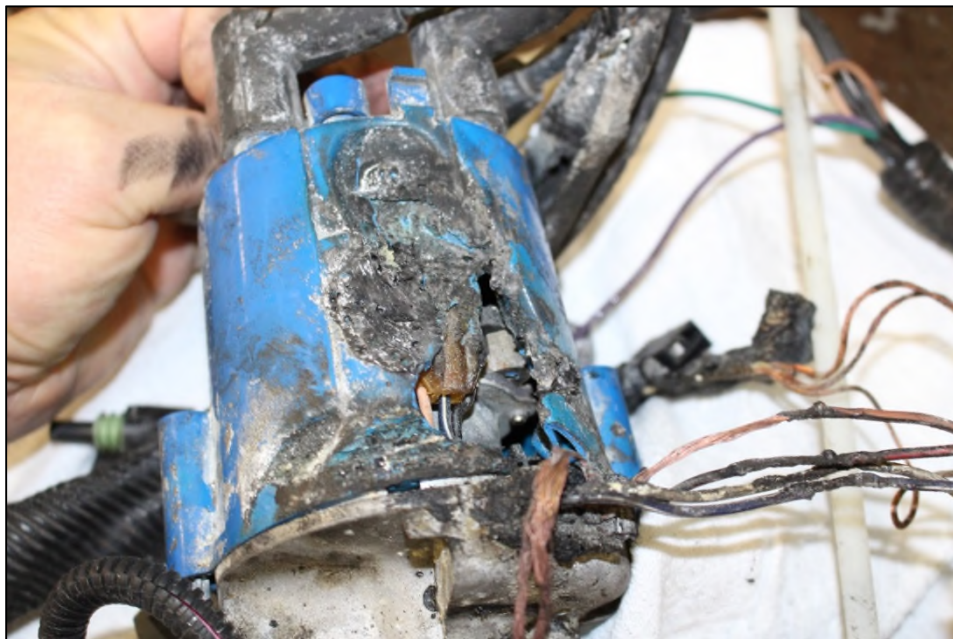
Photograph 12

View of the fire damage to the distributor cap.

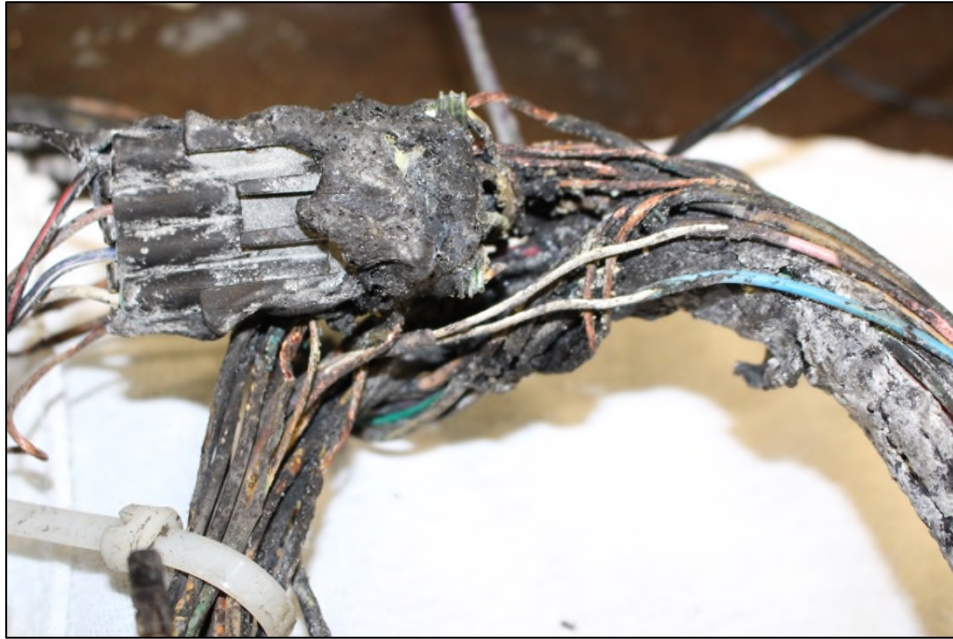
Photograph 13

View of the fire damage to the wiring harness.

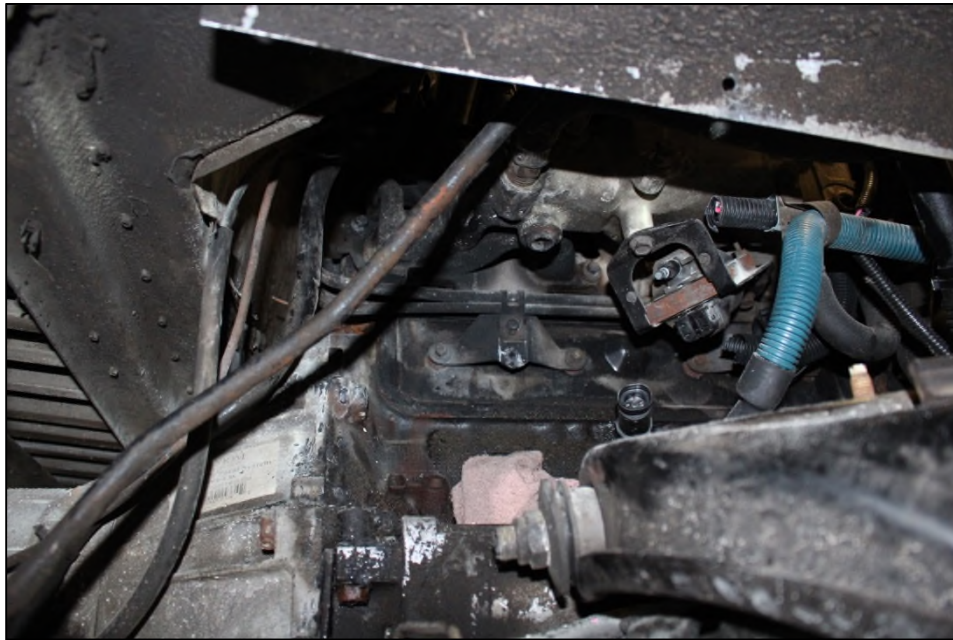
Photograph 15

View of the area of origin after the wiring harness and the distributor cap have been removed from the vehicle.

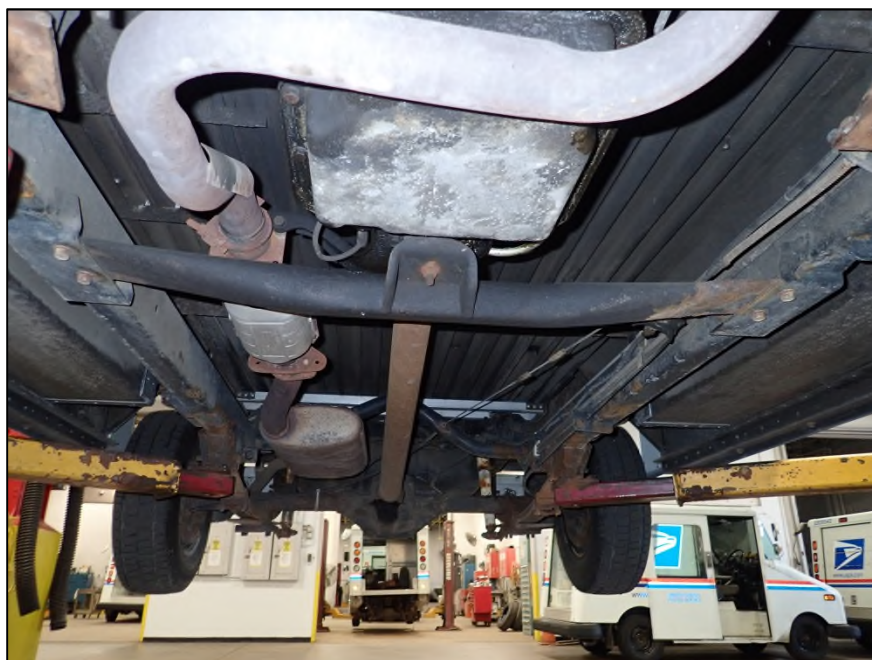
Photograph 10

Undercarriage in the rear of the vehicle.

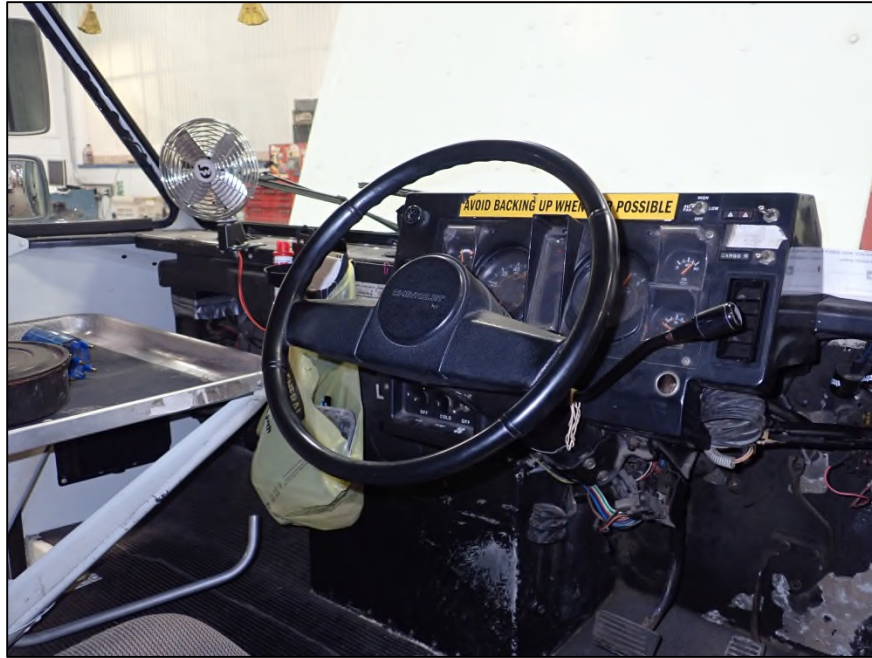
Photograph 11
Dashboard of the vehicle.

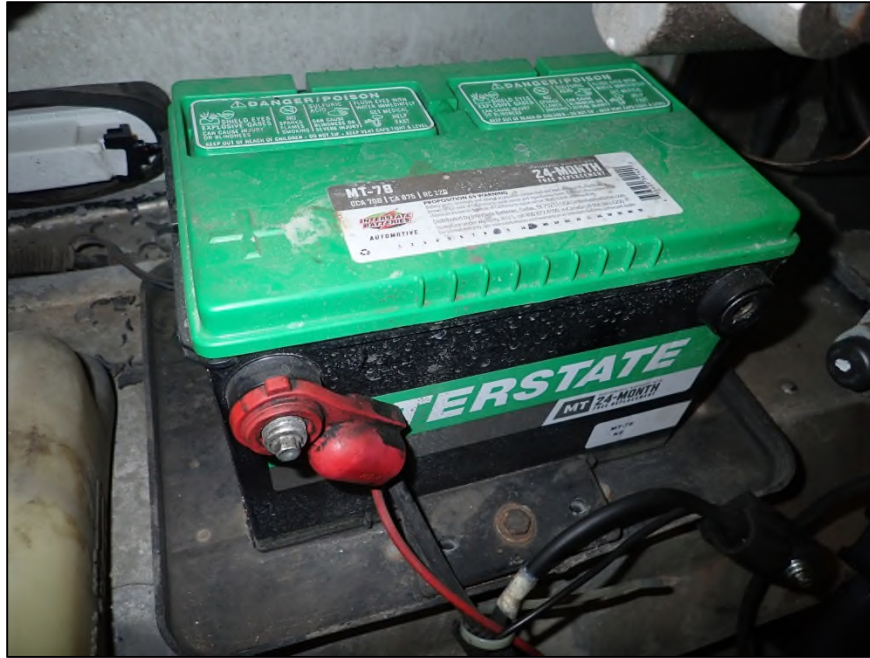
Photograph 13

Battery in the engine compartment.
